J Nondestruct Eval (2013) 32:372–383
DOI 10.1007/s10921-013-0191-y

Experimental Study on Ultrasonic Monitoring of Splitting Failure in Reinforced Concrete

Magdalena Rucka · Krzysztof Wilde

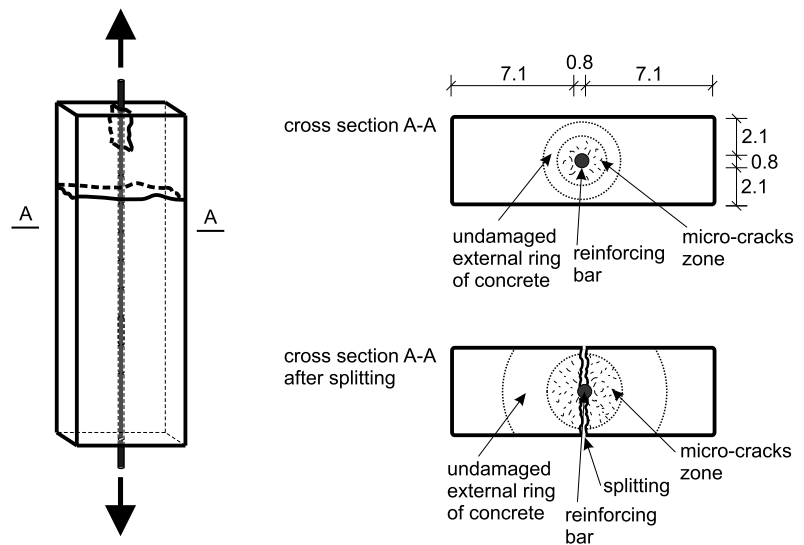
Fig. 1 Considered concrete specimen in tension and sketch of formation of micro-cracks before and after splitting (dimensions shown in cm)

The splitting failure is a complex phenomenon that can lead to a collapse of a whole concrete element. Sensitive to the splitting failure are elements with reinforcement bars in tension with high bound stresses like anchorages with limited transverse pressure, heads of pre-stressed, pre-tensioned thin webbed beams [18]. The splitting failure of concrete elements is caused by a local collapse of the bond between steel bars and surrounding concrete. During loading, at first stage, radial micro-cracks develop in a limited zone around the reinforcement bar. The external ring of undamaged concrete provides sufficient confinement that prevents splitting. At large external loads the undamaged external ring becomes too thin and cracks spread through the element. When the splitting failure occurs the bond between the reinforcement and concrete is lost and cracks are wide open resulting in significant reduction of loading capacity. Problems of the bond and the splitting failure have been investigated by many researchers, e.g. [18–20]. Gambarova et al. [18] carried out tests on the concrete splitting along an anchored bar subjected to a pull-out force. Numerical analyses of the bond splitting failure were conducted by Ogura et al. [19]. Gálvez et al. [20] presented an experimental study on the bond-splitting in precast prestressed concrete during the release of a prestressing force. They examined the longitudinal splitting of the concrete specimens of dimensions $40 \times 6 \times 6$ cm with one wire of diameter 4 mm embedded longitudinally in the specimen. The release of the load in the wire caused the longitudinal splitting of the concrete prism.

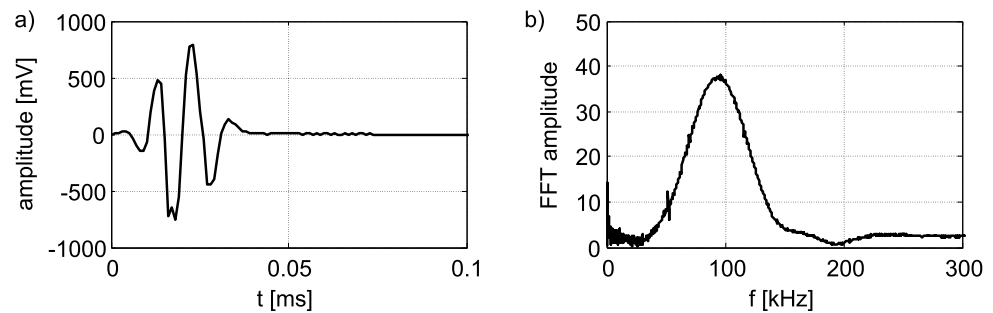
Fig. 4 Excitation signal: (a) in time domain; (b) in frequency domain

The excitation signal considered in this study was chosen as a single-frequency smoothed tone burst (also known as a wave packet) obtained from the multiplication of a sinusoidal function of established frequency by a Hanning function. The Hanning window provides smoothed tone burst in order to reduce the excitation of side frequencies [17]. This aspect of excitation of coherent single-frequency waves is important in the context of ultrasonic diagnostics. The number of cycles in the tone burst has a strong influence on the bandwidth of the input signal. For the established frequency of the sine wave, a large number of cycles is advantageous to obtain a narrow band in the frequency domain. On the other side, too many cycles causes increasing of wave packet length in the time domain. In this study, a four-peak sinusoidal signal with a central frequency of 96 kHz modulated by the Hanning window (Fig. 4) was chosen as a compromise between acceptable level of resolution in the time and frequency domains.

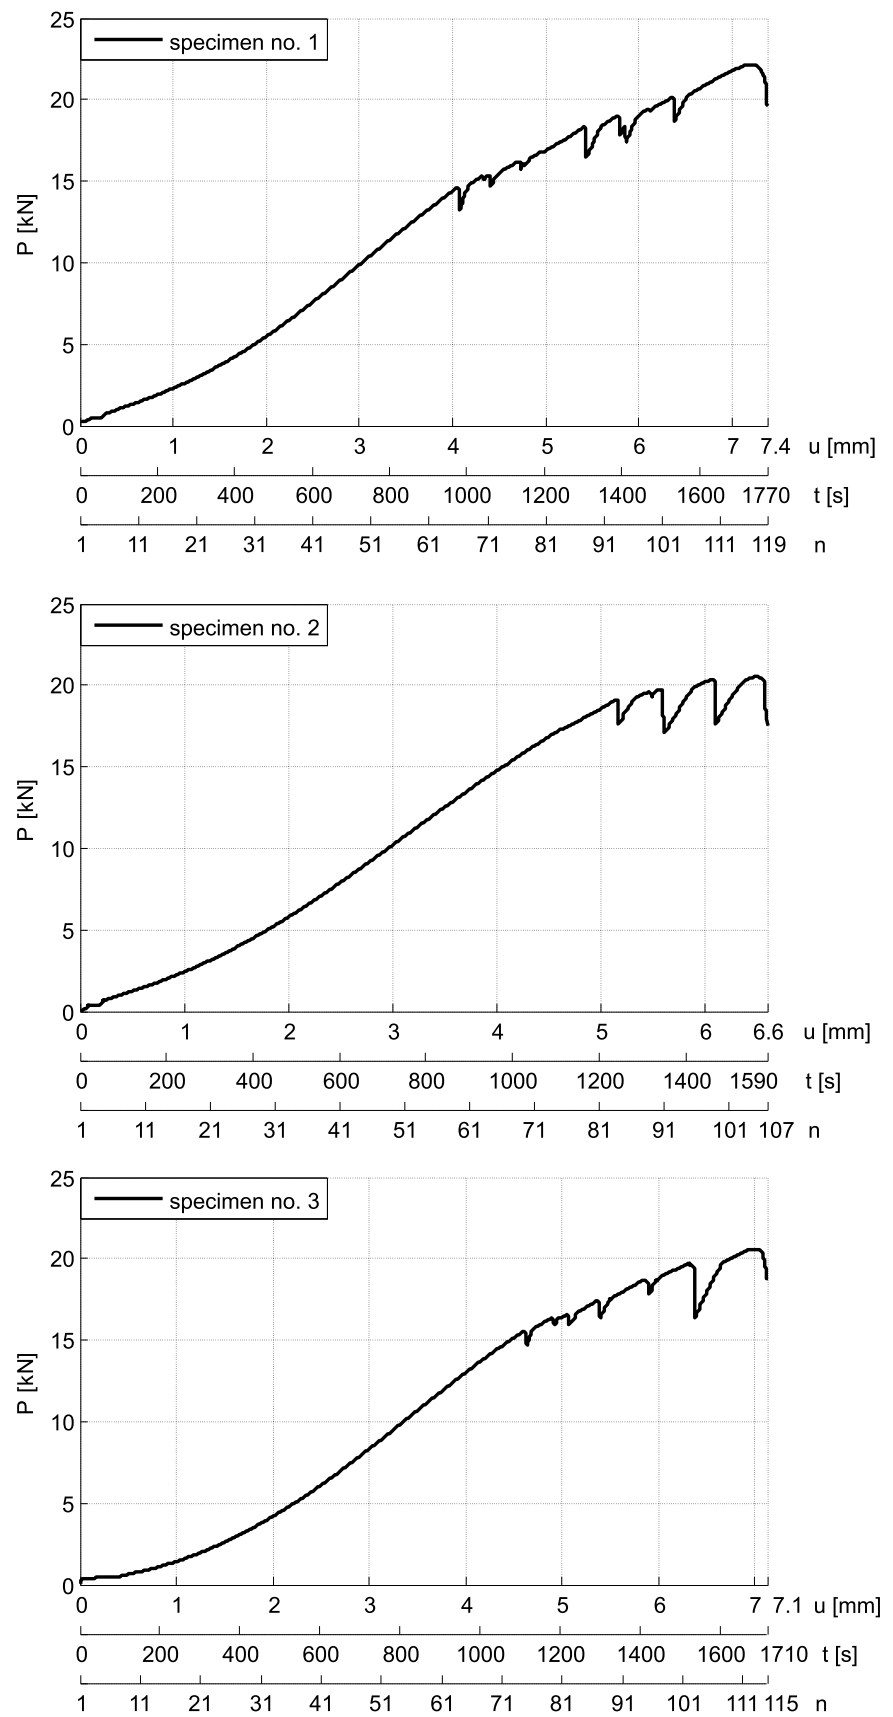
Fig. 5 Experimental load-deflection ($P-u$) and load-time ($P-t$) curves of three reinforced concrete specimens

During the tensile tests, the displacement of the cross-head and the force level were recorded. Figure 5 shows the force-displacement ($P-u$) and the force-time ($P-t$) curves for the tested specimens. There are sudden drops of the force at the moments when the major splitting cracks appear and the load distribution within the specimen alters in time. It was noted that the sizes of the notches were not identical within the given element since they were cut by hand. The time of duration of the tensile test was 1770 s, 1590 s and 1710 s for specimen no. 1, no. 2 and no. 3, respectively. The maximum displacement u_{\max} of the cross-head in the longitudinal direction was 7.38 mm, 6.6 mm and 7.12 mm for specimen no. 1, no. 2 and no. 3, respectively. During the tensile test, wave propagation measurements were conducted. Time signals were taken each 15 seconds and each signal was assigned ordinal number n . Parameter n started from $n = 1$

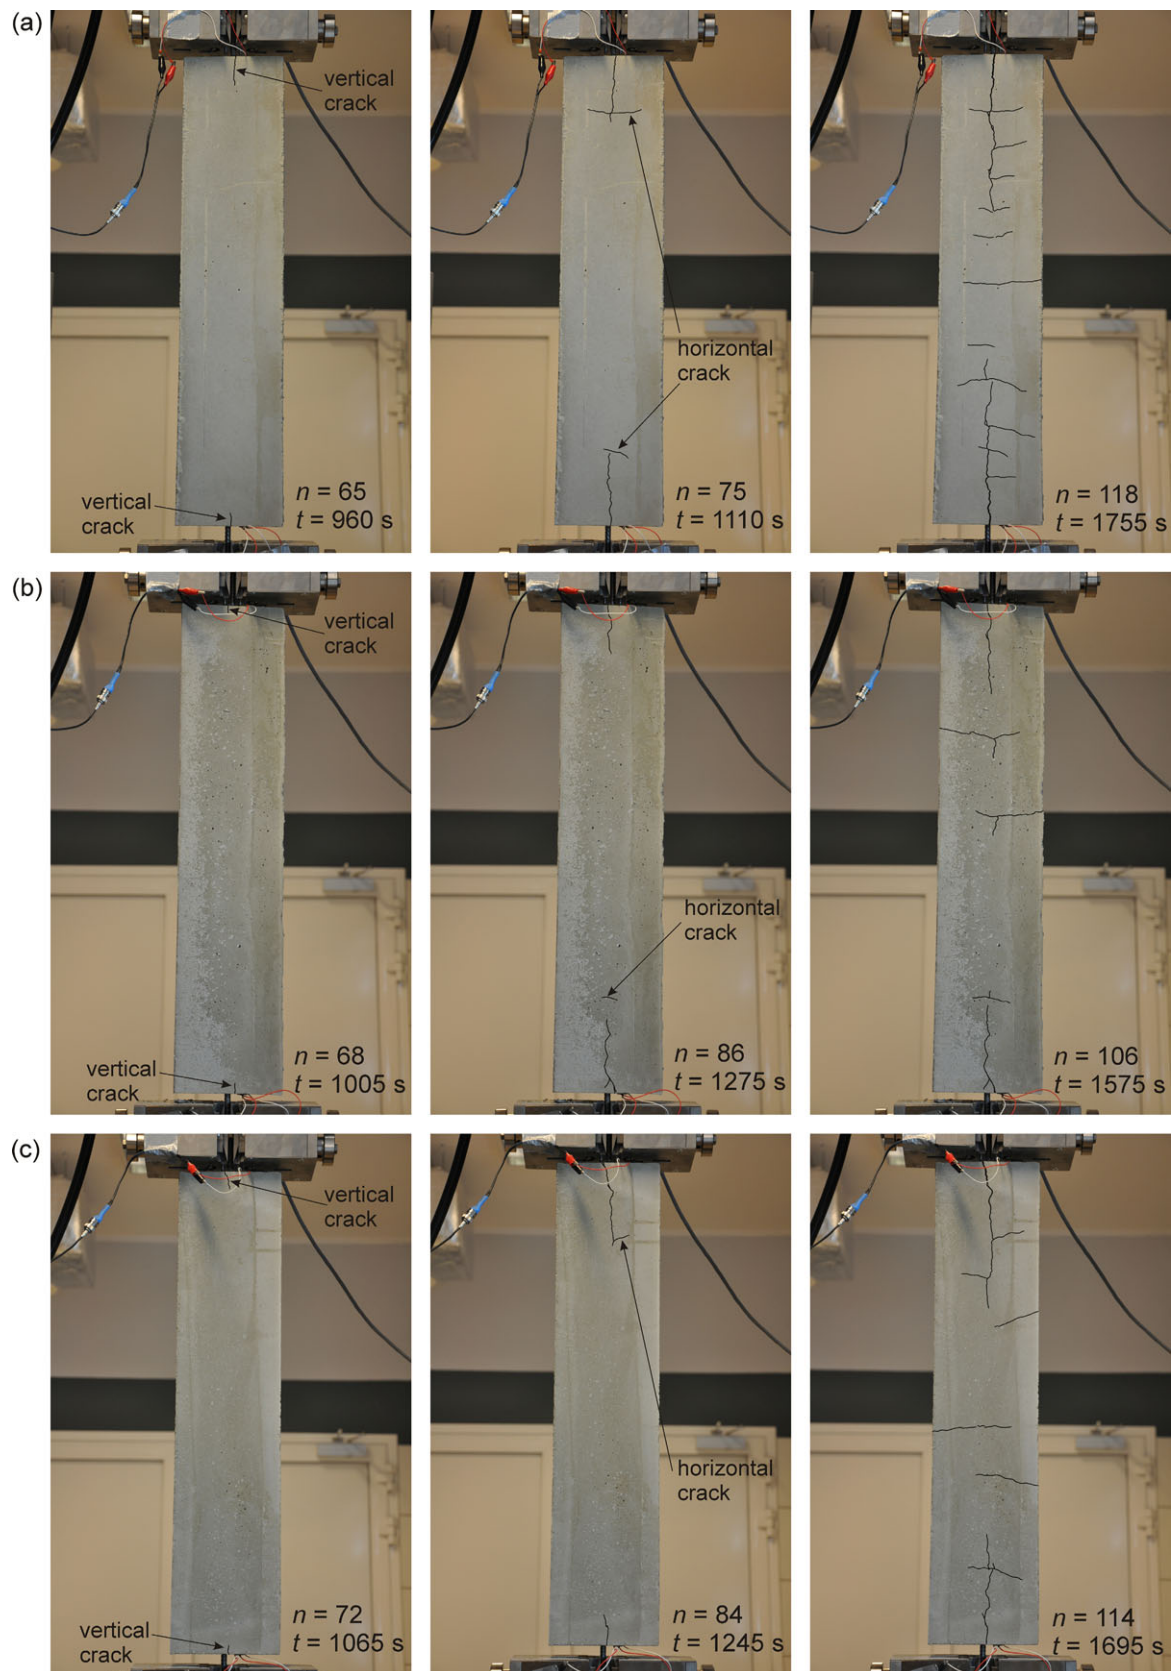
Fig. 6 Experimental damage evolution and crack patterns of three tested specimens (state of initiation of vertical cracks, state of initiation of horizontal cracks, penultimate stage of damage): (a) specimen no. 1; (b) specimen no. 2; (c) specimen no. 3

Figure 6 presents the crack formation and damage evolution in the tested specimens at the increasing load levels. At the first stage of the fracture process, two vertical cracks started to develop at the top and the bottom of the specimen. These cracks were initiated at $t = 960$ s ($n = 65$, $u = 0.54u_{\max}$) for specimen no. 1, at $t = 1005$ s ($n = 68$, $u = 0.63u_{\max}$) for specimen no. 2 and at $t = 1065$ s ($n = 72$, $u = 0.62u_{\max}$) for specimen no. 3 (the first column of photographs in Fig. 6). Next the horizontal splitting of the concrete prism appeared at $t = 1110$ s ($n = 75$, $u = 0.62u_{\max}$) for specimen no. 1, at $t = 1275$ s ($n = 86$, $u = 0.80u_{\max}$) for specimen no. 2 and at $t = 1245$ s ($n = 84$, $u = 0.73u_{\max}$) for specimen no. 3. This stage of damage is illustrated by the second column of photographs in Fig. 6. The penultimate stage of damage is given in the third column in Fig. 6. It occurred at $t = 1755$ s ($n = 118$, $u = 0.99u_{\max}$) for specimen no. 1, at $t = 1575$ s ($n = 106$, $u = 0.99u_{\max}$) for specimen no. 2 and at $t = 1695$ s ($n = 114$, $u = 0.99u_{\max}$) for specimen no. 3. The tensile tests were stopped as a result of the tension failure of the steel bar. Figure 7 shows the details of the concrete specimen after the splitting failure. The prints of the lugs of the reinforcing bar are clearly seen on the piece of damaged concrete. Therefore, the slipping of the steel bar and damage of the bar surrounding concrete by the tips of the rebar lugs did not take place.

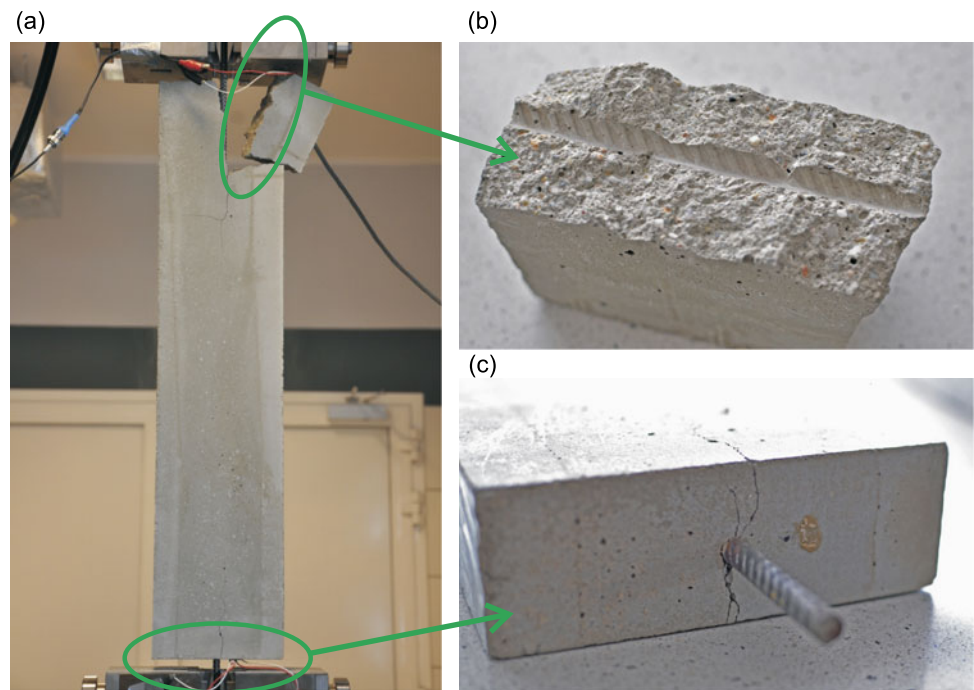
Fig. 7 Specimen no. 3 after damage: (a) the view of the specimen; (b) interface between steel and concrete; (c) splitting cracks on the bottom part of the specimen

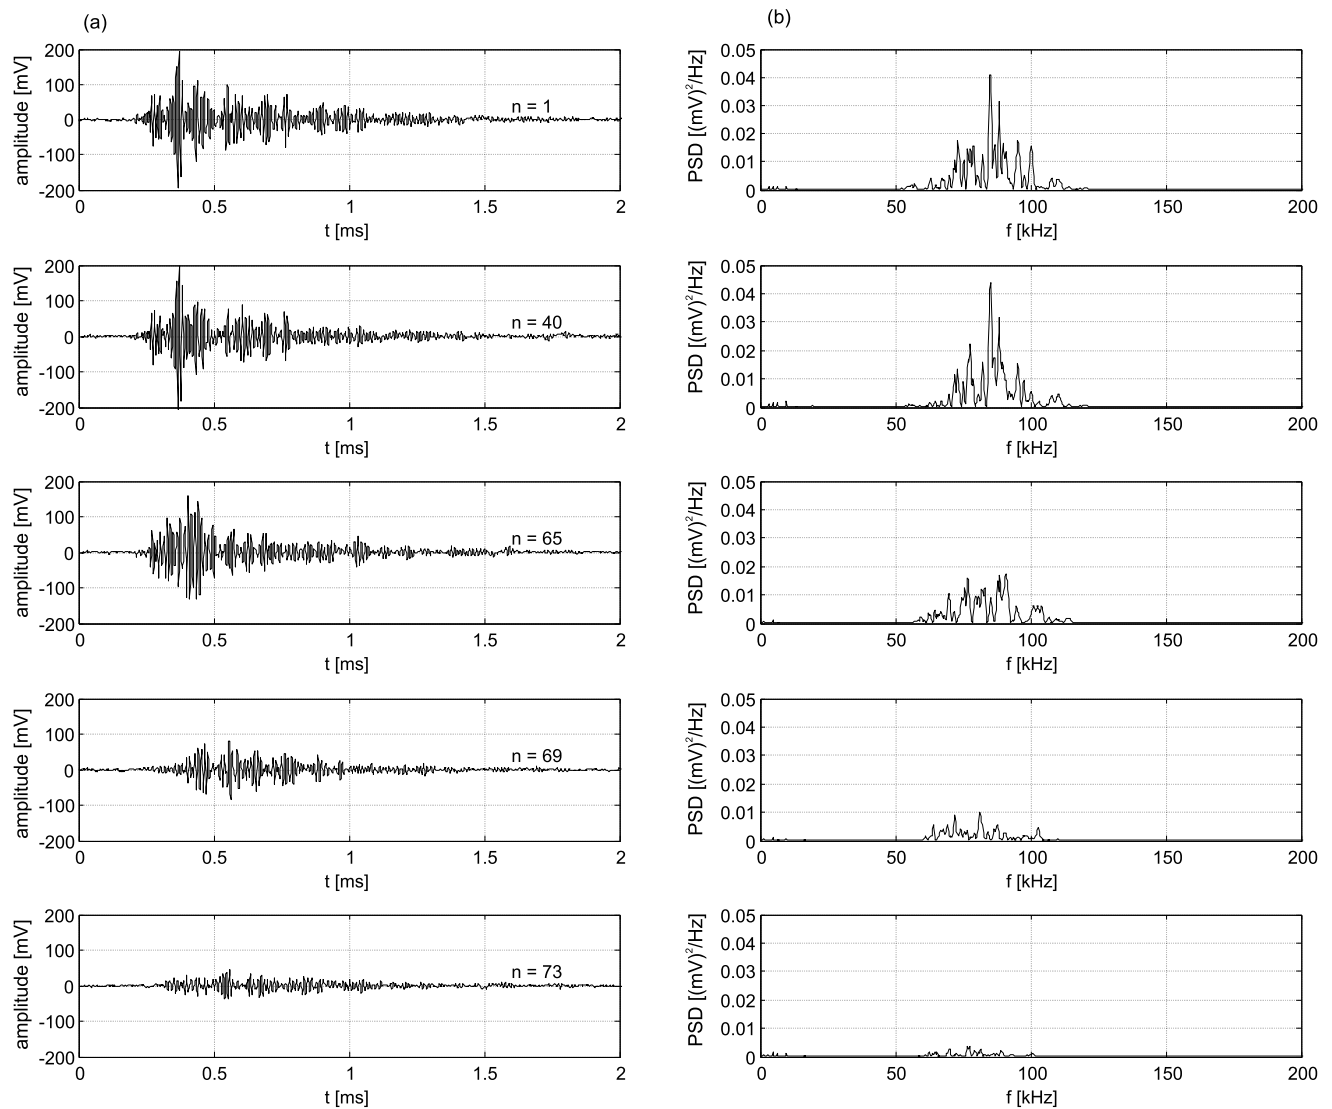
Fig. 8 Ultrasonic signals registered at point B in specimen no. 1 for different load levels: (a) A-scan signals in time domain; (b) power spectral densities of time waveforms

The maximum amplitudes of the signals acquired at point B (on the opposite side then the PZT actuator) were practically the same for the signals from $n = 1$ to $n = 65$ and, then they decreased with the increase of the external tensile loading.

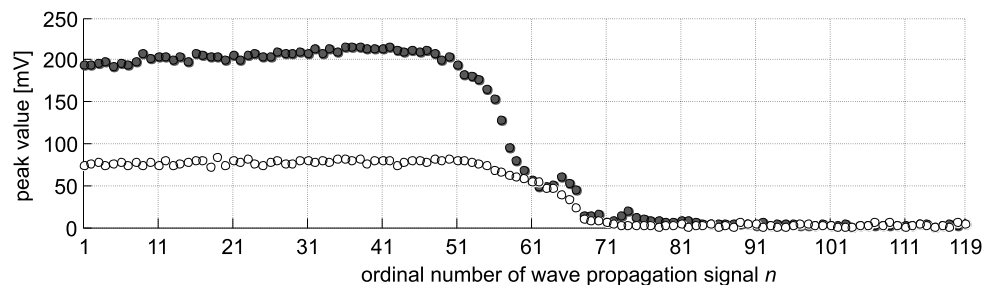
Fig. 9 Peak values of wave propagation signals registered at point B in the specimen no. 1: the first wave packet corresponding to the first pressure wave traveling in the specimen (white dots) and the second wave

packet associated with interference of shearing and pressure waves reflected from the specimen cross-section boundaries (grey dots)

Figure 9 shows the peak values of the signals registered at point B for the specimen no. 1. Data in Fig. 9 are taken from the time signals (so called A-scans) for consecutive measurements of propagating ultrasonic waves. Peak values of the first incoming wave packet for the signals from $n = 1$ to $n = 119$ were plotted with white dots (Fig. 9). The first wave packet corresponds to the first pressure wave traveling in the specimen. The initial value of the peak was of about 80 mV. The first wave packet can be clearly seen for signal numbers from $n = 1$ to $n = 40$ (Fig. 9a). For the time records corresponding to higher signal numbers, the peak values of the first wave packet were determined for the time range $t = 0.27\text{--}0.28$ ms. The peak values of the second wave packet that can be seen at $t = 0.37\text{--}0.38$ ms were plotted in Fig. 9 with grey dots. The initial peak value of the second waveform was of about 200 mV. The second wave packet was associated with interference of shearing and pressure waves reflected from the specimen cross-section boundaries. The recognition which wave packet in the registered signal corresponds to pressure and shear waves was done based on wave velocities.

The amplitudes of the first wave packet were similar for the signal numbers from $n = 1$ to $n = 55$ (Fig. 9). From $n = 56$ to $n = 67$ the amplitudes started to decrease and from $n = 68$ they became close to zero. Small micro-cracked

zones did not significantly affect the first pressure wave, and therefore, the significant drop of the maximum amplitudes was noticed when the first vertical crack appeared (at $n = 65$). The amplitudes of the second wave packet were constant for signal numbers from $n = 1$ to $n = 51$ and the relatively rapid decrease of the amplitudes took place till $n = 61$. At signal number $n = 75$ the maximum amplitudes of the second wave packet became very small. It seems that the change of the peak values of the second wave packet indicated the development of the micro-crack zone before splitting takes place. The vertical splitting cracks were observed for $n = 65$ while the reduction of the amplitudes starts at $n = 51$. Formations of micro-crack zones had relatively large influence on the reflected shear and pressure waves resulting in large attenuation of the second wave packet.

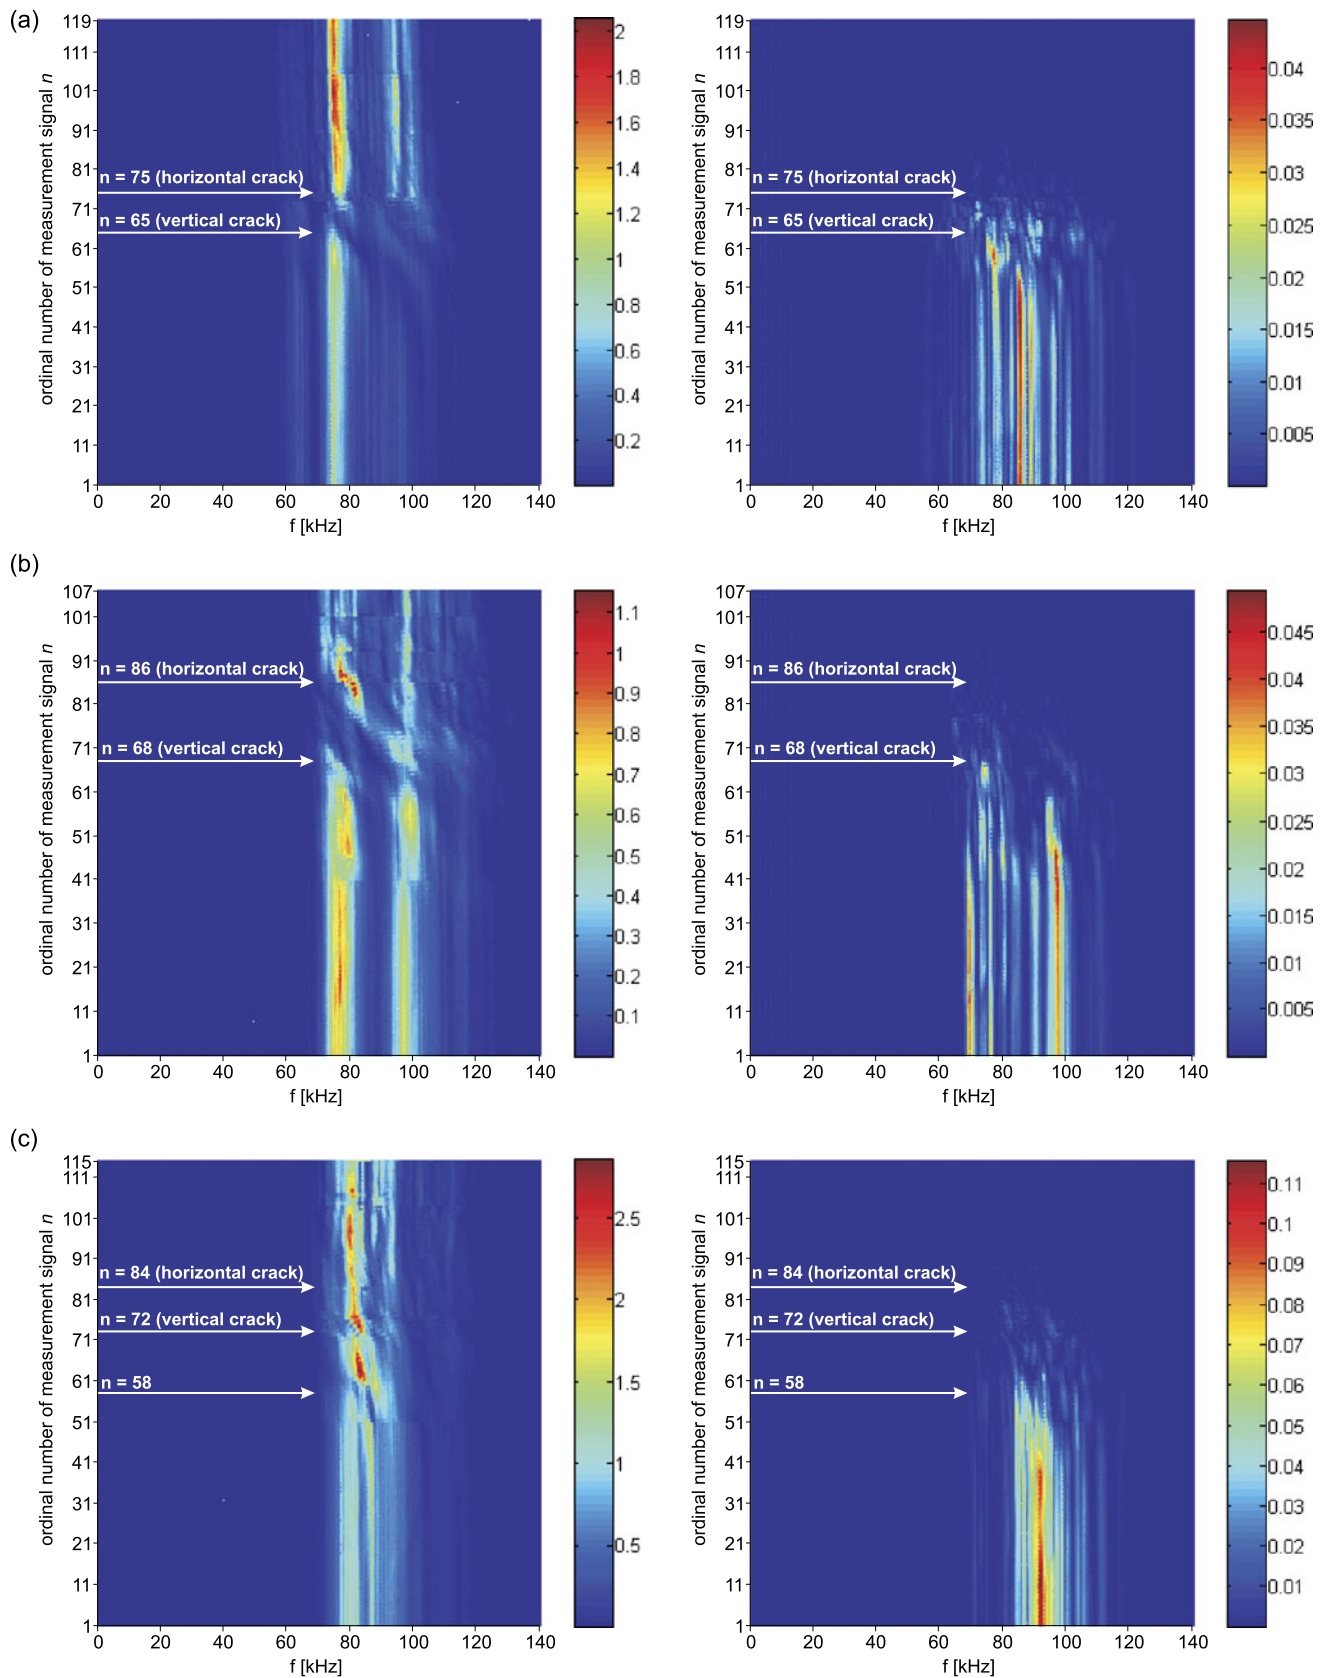
Fig. 10 Power spectral density maps of registered signals at point A (left column) and at point B (right column): (a) specimen no. 1; (b) specimen no. 2; (c) specimen no. 3 (power spectral densities are in units of $(\text{mV})^2/\text{Hz}$)

The evolution of the frequency spectrums in time for specimen no. 1, 2 and 3 are shown in Fig. 10. The power spectral densities of all ultrasonic signals acquired during the tensile test were plotted in the form of maps. White arrows indicate two characteristic measurements for each specimen: the measurement associated with the appearance of the first vertical crack and the measurement associated with the appearance of the first horizontal crack. The right column of Fig. 10 illustrates the power spectral densities of the A-scan signals measured at point B. It can be observed, that the amplitudes decreased with the increase of the damage stage. At the moment of the first vertical crack development, the amplitudes of the PSD revealed sudden change. The decrease in amplitudes occurred in a quasi-

linear way, i.e. first higher frequency components decreased, while lower frequencies decreased at a later stage of damage.

The left column of Fig. 10 presents the power spectral densities of the signals measured at point A. These signals had similar amplitudes during all measurements because of

their close location to the PZT actuator. Clear oblique lines are visible in the PSD maps for all specimens. At the moment of initiation of vertical crack, local decrease in the PSD amplitudes can be observed. It started at $n = 65$ for the specimen no. 1 and $n = 68$ for the specimen no. 2. This local decrease had an oblique line shape, i.e. first higher frequencies are damped, while the lower frequencies are damped at the next time instances. In the specimen no. 3 the first vertical crack was observed for measurement $n = 72$. However, it can be seen at the PSD map, that additional local decrease of amplitudes occurred ($n = 58$), probably as a result of other vertical crack on the opposite side (not monitored by camera).

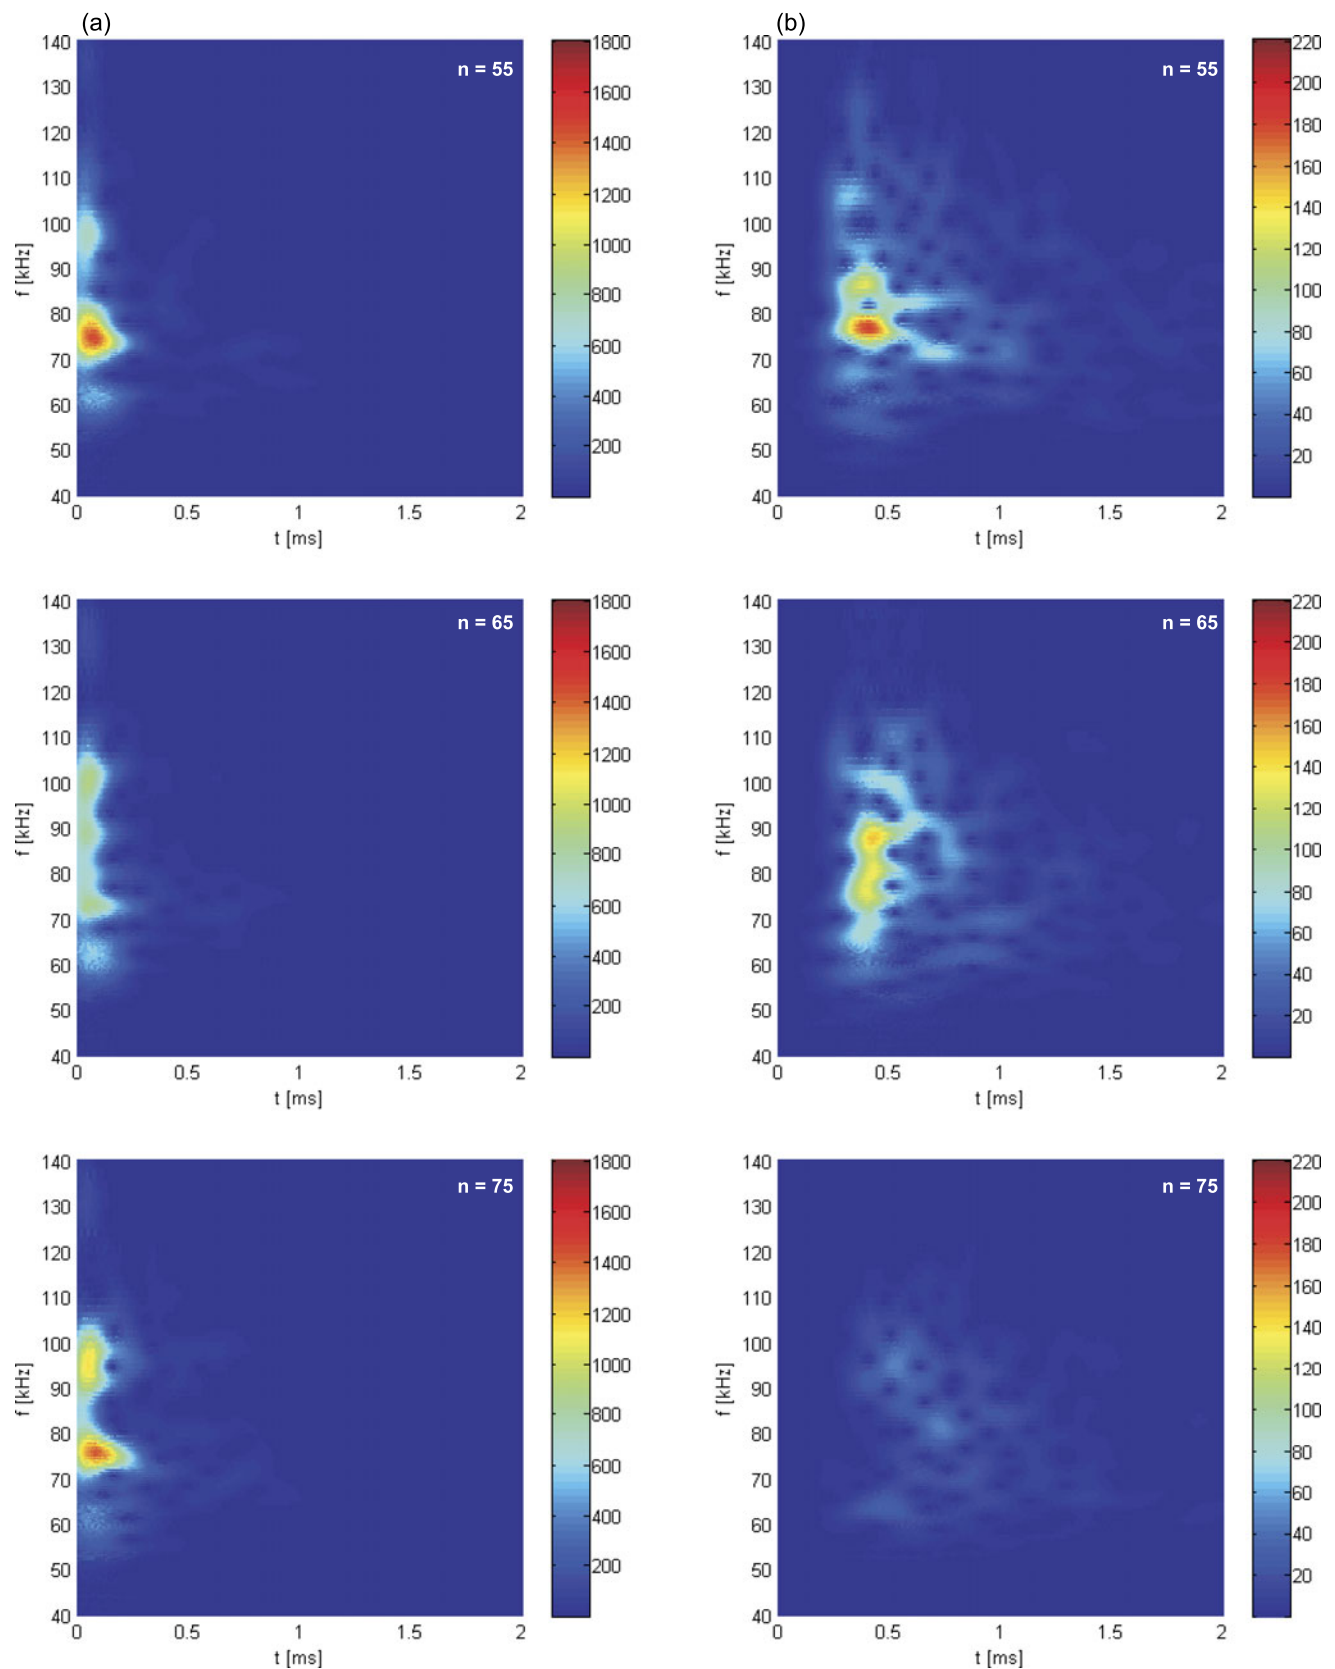
Fig. 11 Wavelet transforms for specimen no. 1 for different load levels: (a) signals registered at point A; (b) signals registered at point B (wavelet transforms are in units of mV)

The wavelet transform results for the selected A-scan signals for specimen no. 1 are presented in Fig. 11. The left column of Fig. 11 shows the wavelet coefficients of the signals registered at point A and the right column depicts the wavelet coefficients of signals registered at point B for time steps corresponding to $n = 55$ (stage before splitting), $n = 65$ (appearance of the first vertical splitting crack) and $n = 75$ (after the splitting failure). For $n = 55$, the elastic waves of frequency 76 kHz travelled through the concrete specimen and they can be observed in both signals measured at points A and B. At the beginning of development of the first splitting crack ($n = 65$), the micro-crack zones were the biggest, causing a significant reduction of the amplitudes of ultrasonic waves at points A and B. Wave packets had frequency range from 70 kHz to 100 kHz. Further increase of

the external loading (e.g. $n = 75$) resulted in the appearance of several large splitting crack and yielding of the steel bar. Plastic deformation of the bar near the notch changed the longitudinal load distribution. Largest deformations were in the areas near the notches. The internal forces in the specimen in the region from its top (the location of point A) to the first horizontal splitting crack were reduced. Therefore, the micro-crack zone became smaller and the waves generated in the neighbourhood of the measurement point A could travel with relatively small damping. Figure 11a (left column) shows large wavelet coefficients at frequency 76 kHz and 96 kHz for the specimen after splitting failure ($n = 75$). The right column of Fig. 11b shows the wavelet coefficients of the signals at point B ($n = 75$). There are no large values of the wavelet coefficients since the specimen have been destroyed by the horizontal splitting cracks that prevented propagation of ultrasonic waves from point A to point B through the concrete.
